## Lessons Learned-Refrigerant Pump Down

**Incident Date-**2/14/18 at 8:01 am

**Equipment-** Trane Odyssey, 20t, Model #TTA240H400AA, MFG- 1/2016  
Compressor- Trane Model # CSHD120K0B0M, Part # COM09857

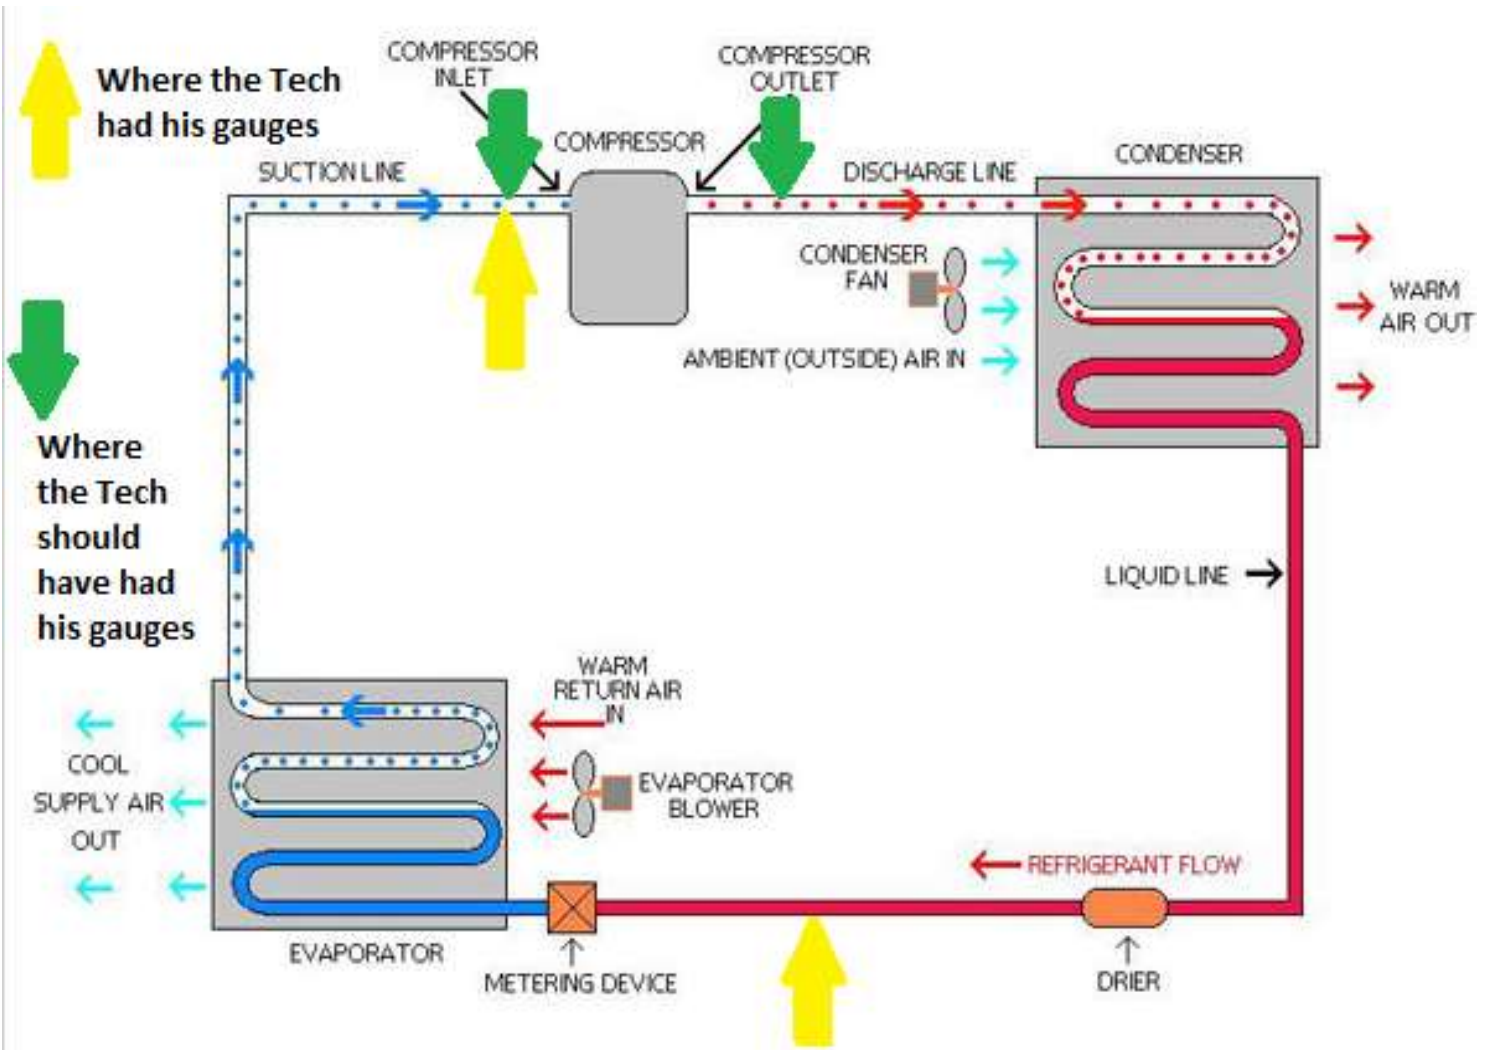
### Gauge attachment diagram

- 1) The technician attached his gauges to the suction and liquid service valves. See diagram below.
- 2) He then closed the liquid service valve.
- 3) He started the compressor by pushing in the contactor with a pen.
- 4) As the refrigerant was being moved into the condenser, the compressor continued to pump (suck) until failure. The discharge line in front of the compressor exploded.

**2) Proper placement of gauges.** See illustration below. By not having a gauge on the discharge line, it did not alert him to the increased PSI to the point of a failure.

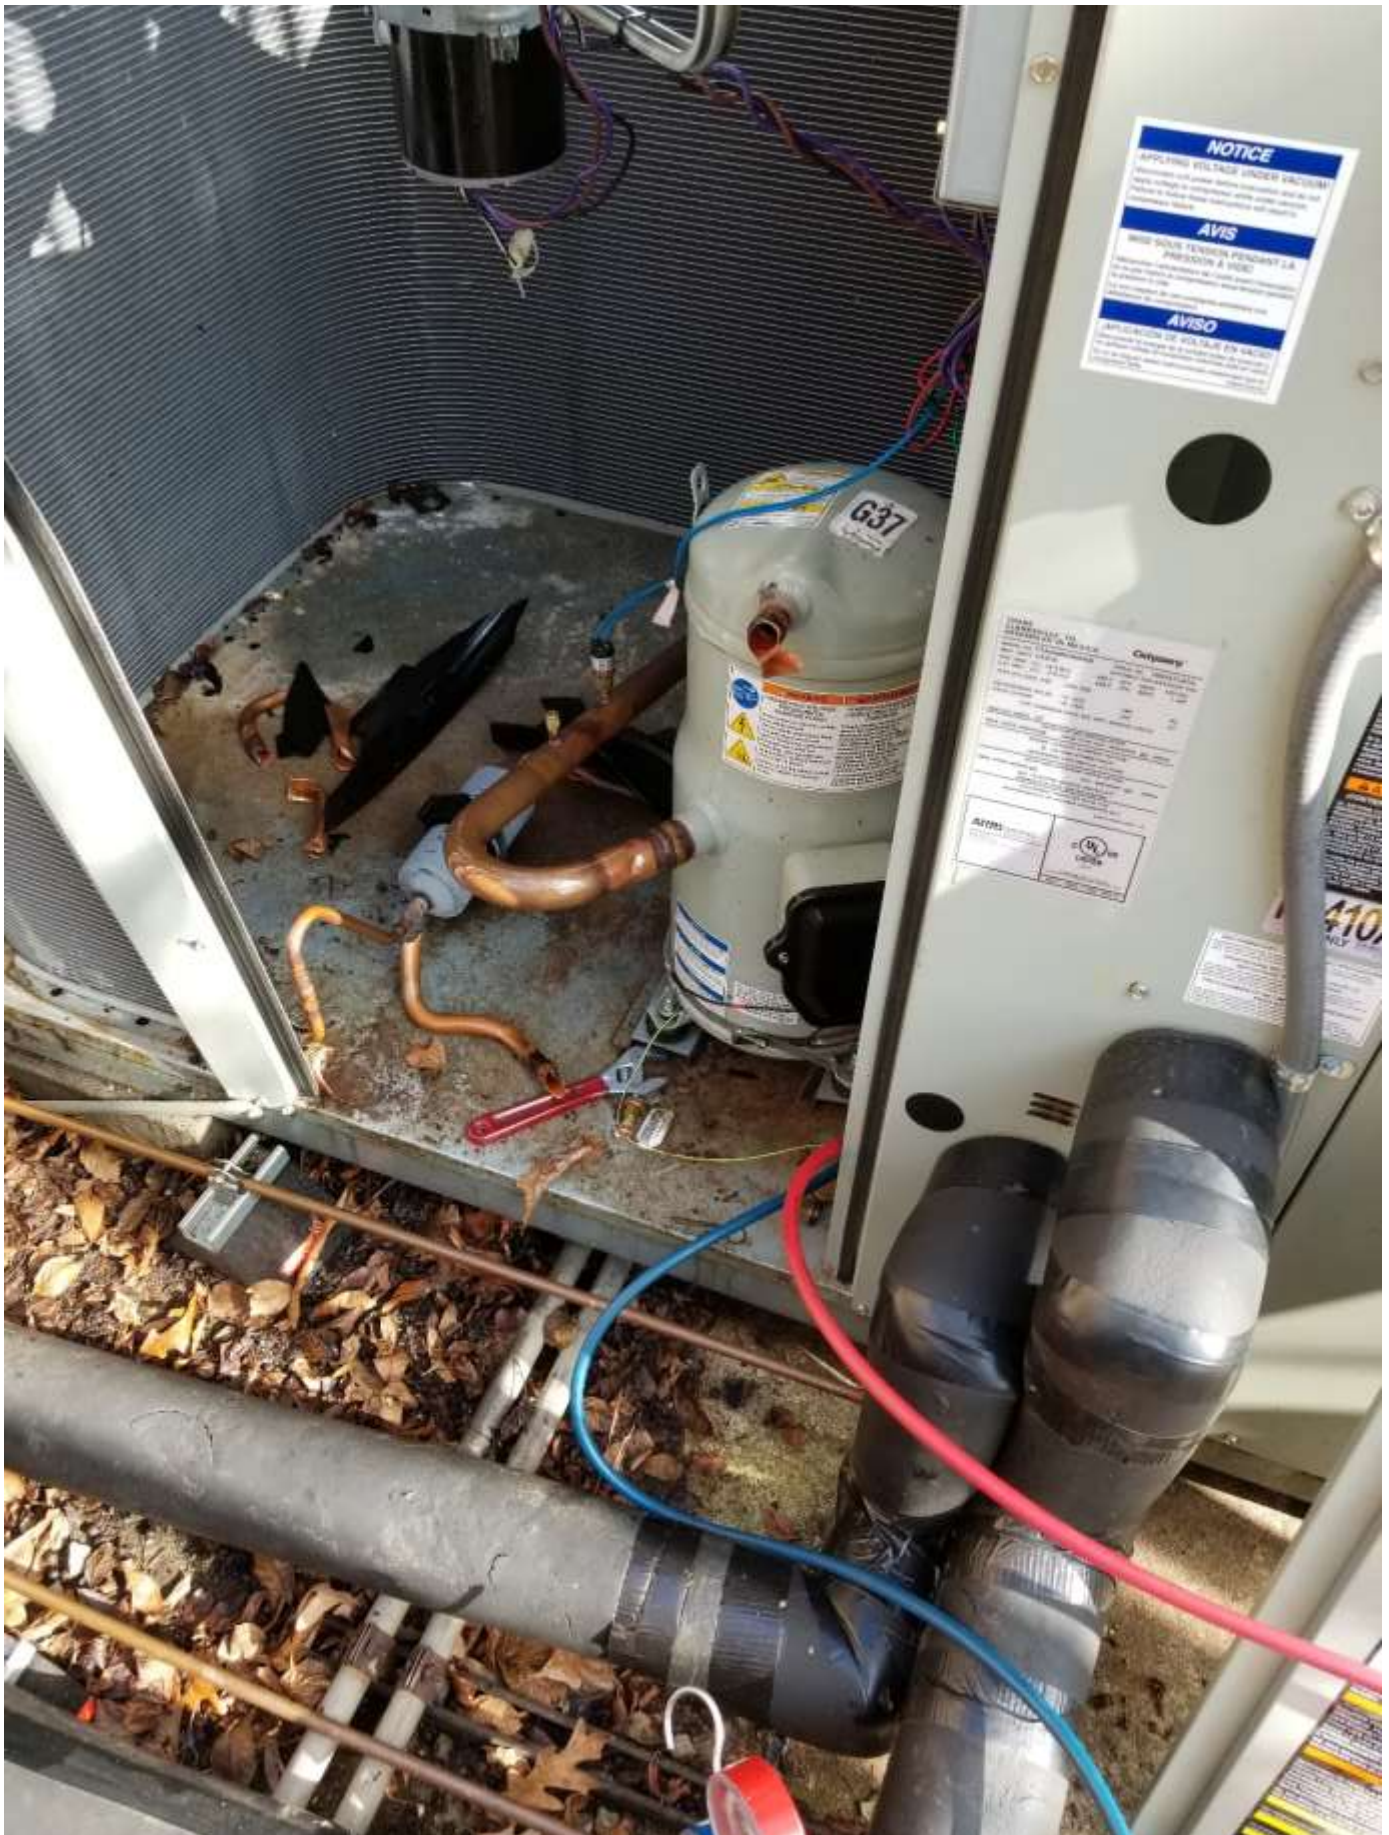
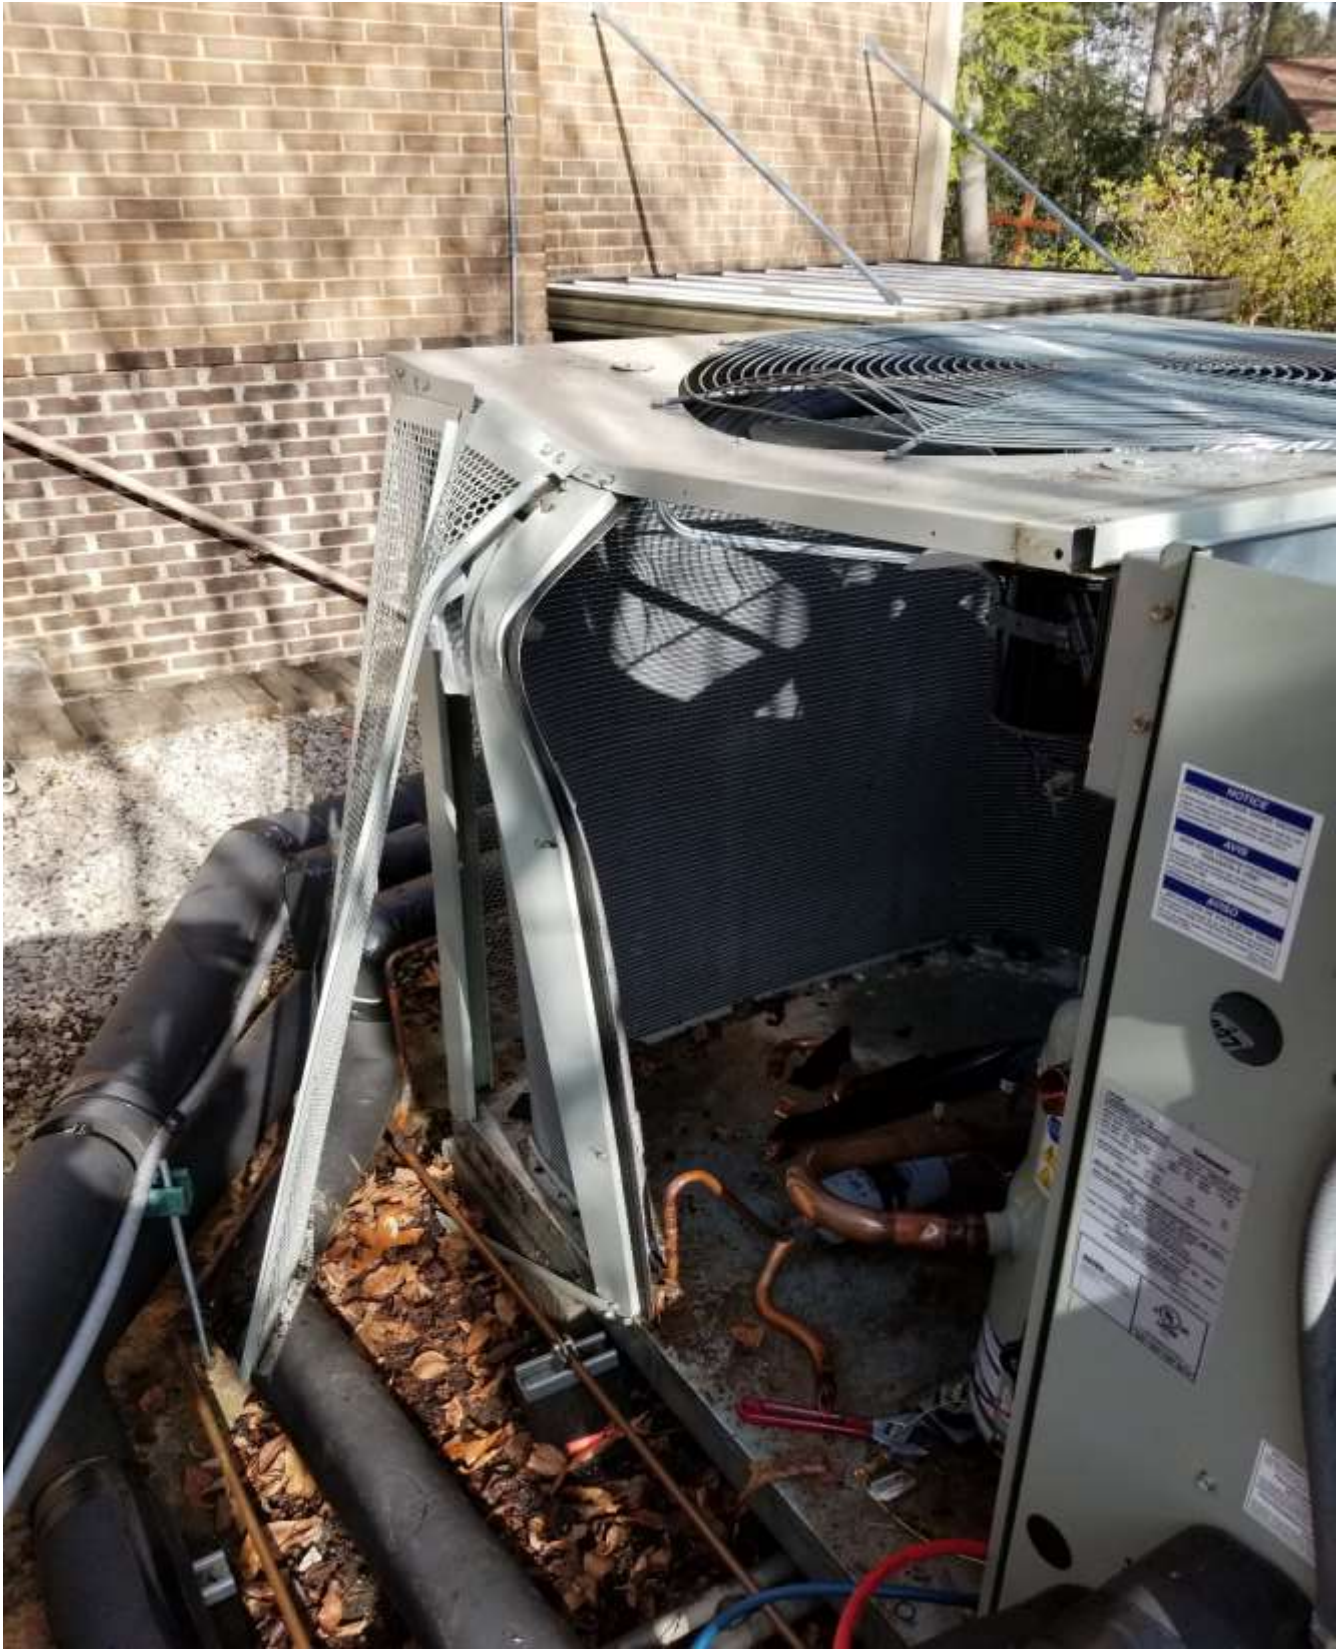
There was an explosion that captured the attention of all around. Our technician was not injured. He was standing to the right side of the compressor as he initiated the contactor. The unit needed replacing.

- 1) Improper means and methods. You cannot perform a pump down procedure on a unit that has micro channel condenser coils such as this unit has. (see excerpt below)
- 2) Pumping down with a scroll type compressor is not recommended by the manufacturer.
- 3) Unfamiliarity with this style of condenser coils.
- 4) Using the contactor to start the compressor overrode the High Pressure Cut Out located in the discharge line. This model Trane Scroll Compressor does not have an internal relief device. (Trane Scroll Compressor Application Data Page 14-High Pressure control)
- 5) His gauges should have been on the suction line and discharge line. This would have shown the pressure increase and alerted him something was wrong. It would have been at least 400 PSI +.
- 6) No Job Hazard Analysis was done.

Here is a picture of the unit right after it exploded

**1) You cannot use a pump down procedure on micro channel coils.**

**3) Do not bypass the safety mechanisms by engaging the contactor.** This could continue to energize the compressor to failure.

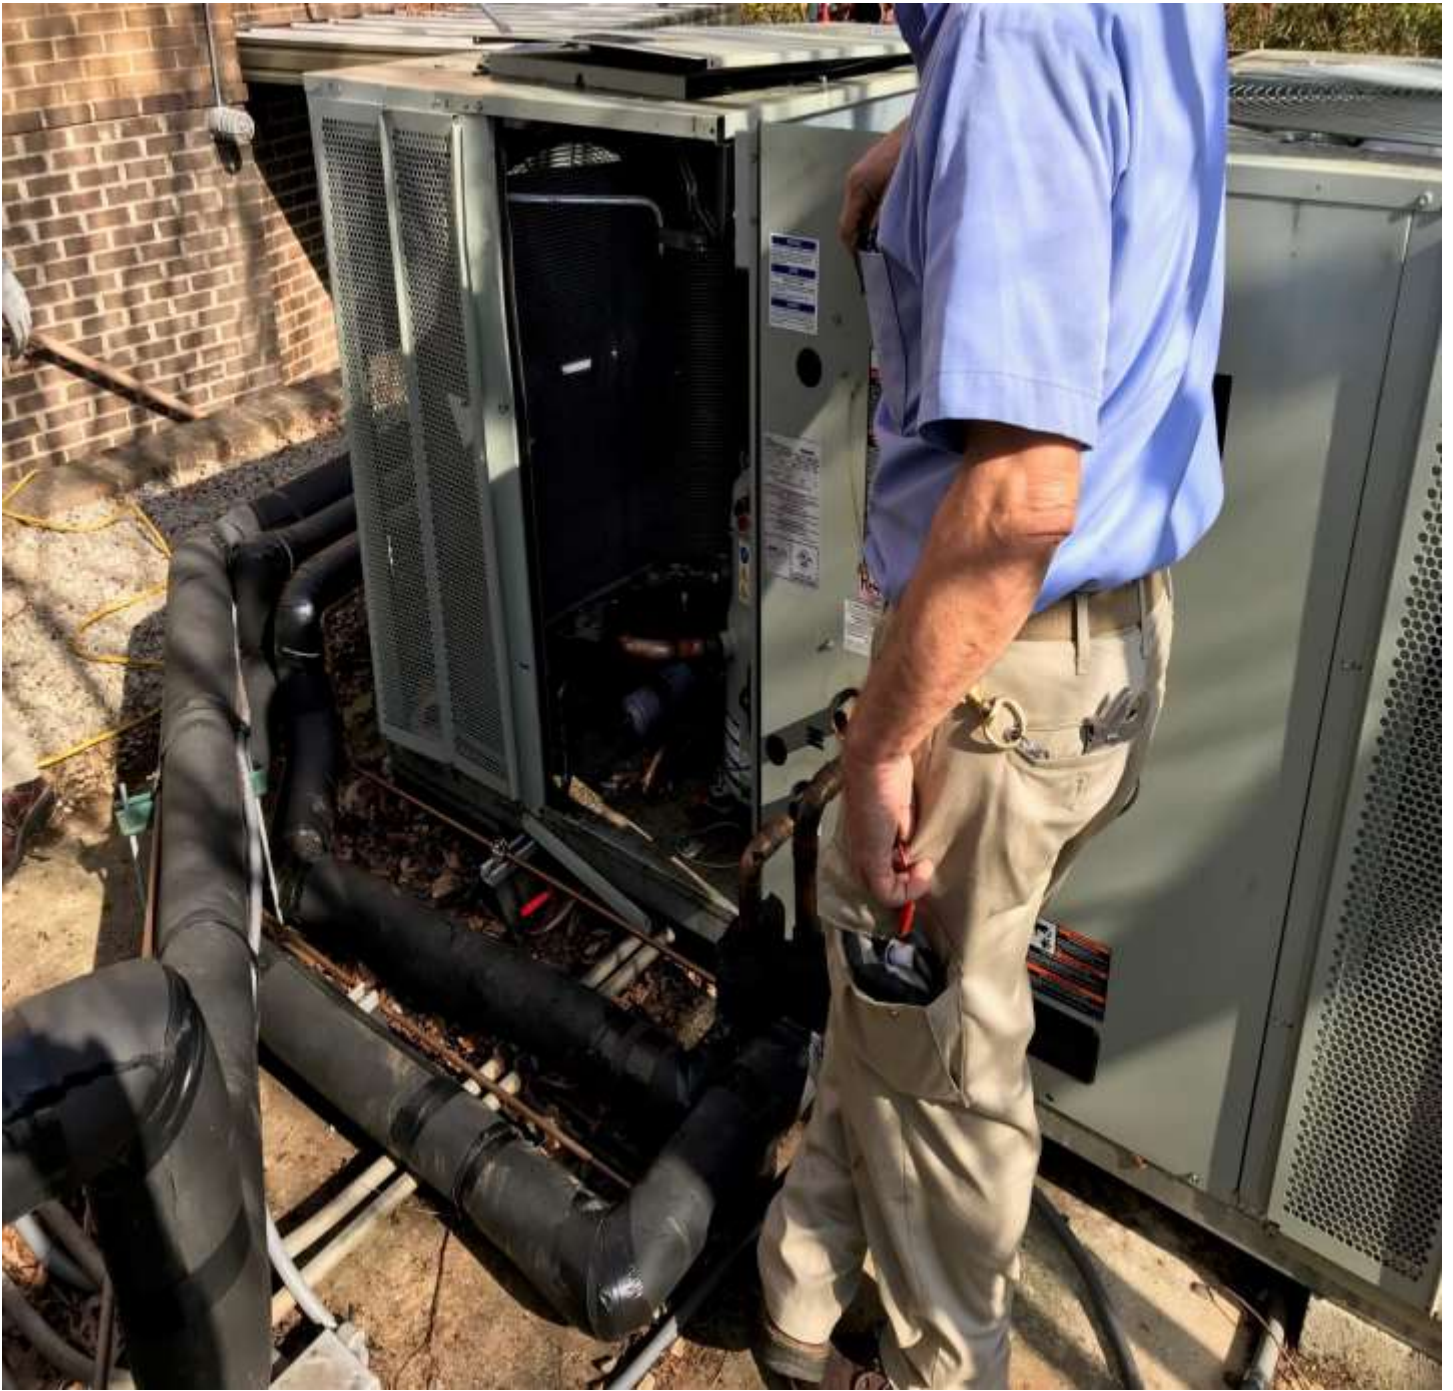
The possible impact from this could have been a fatality if our technician was standing a couple of feet to the left. The force of the explosion did knock him on his tail.

This is where our Technician was standing when it exploded

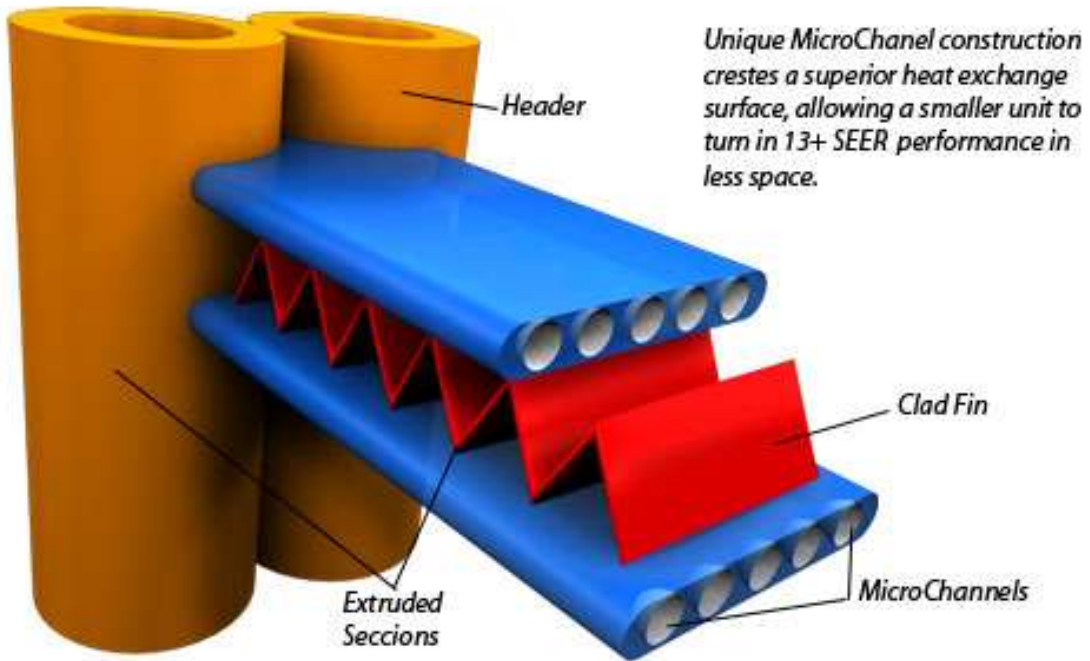
## MicroChannel Design

Pumping down refrigerant into the microchannel condenser coil on a unit with a standard tube and fin evaporator coil is not permissible. The reduced capacity of a microchannel coil compared to that of a tube and fin coil makes it impossible to store any considerable amount of refrigerant charge in the microchannel condenser coil. It still is possible with the addition of suction and discharge line service valves to replace the compressor without removing the total system charge and just evacuating the small amount of refrigerant left between the two valves.

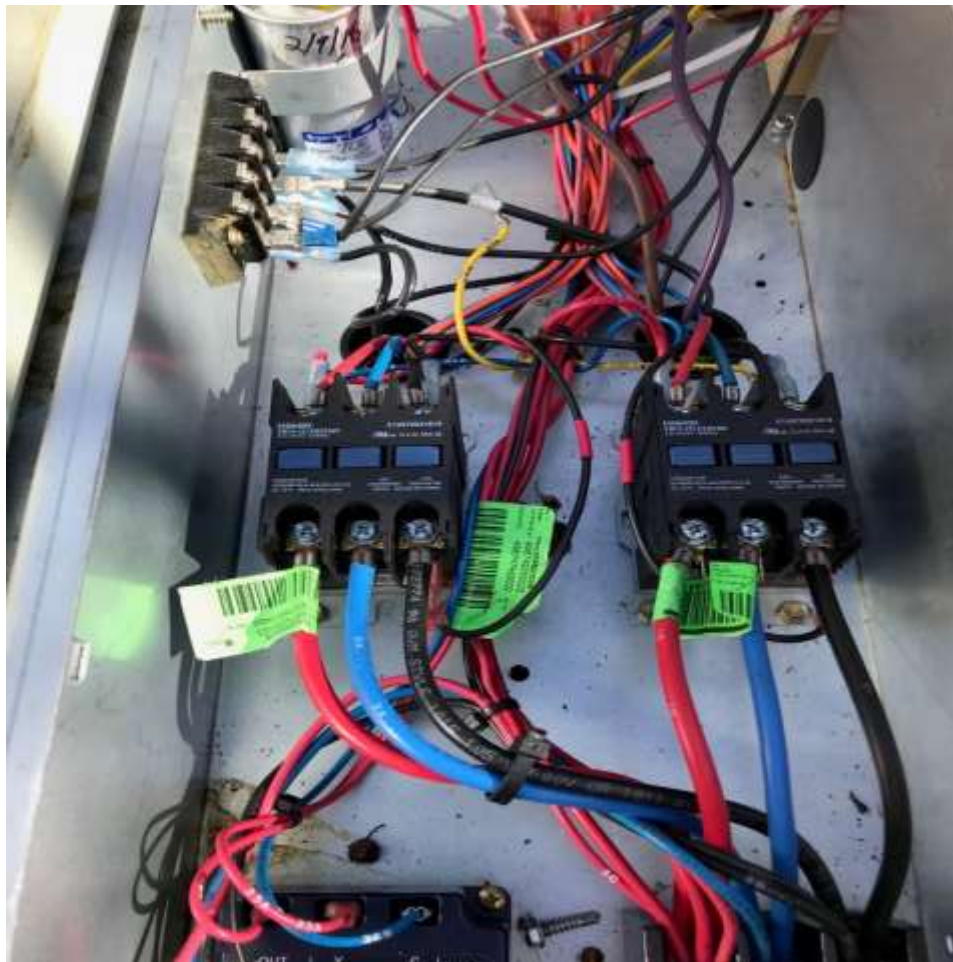
In the investigation of this it was found that no thought was given to shock protection or arc flash protection being the technician was within the Restricted Shock Boundary and Arc Flash Boundary. The technician was about 6" from energized 480v 60a.

This is where our Technician had to engage the contactors, about 6" from energized 480v conductors

For this task, Per NFPA 70e the restricted approach boundary for shock is 1'-0". This means for shock you would wear your rubber gloves with your leather gloves over them.

For the arc flash boundary, per Table D.4.7 calculations for a 60a 480v breaker with an interrupter current of 18 KVA, your arc flash boundary would be at 14"@ 1.2 cal/cm<sup>2</sup>. This means you could perform this task with just a cotton or non flammable shirt and be safe and compliant. (Additional arc flash protection is required when the incident energy is at 18"@ 1.2 cal/cm<sup>2</sup>). Of course, you would still use your safety glasses.
